## Cairnhill Operations 2013 – OFM Capabilities

### Scope of work

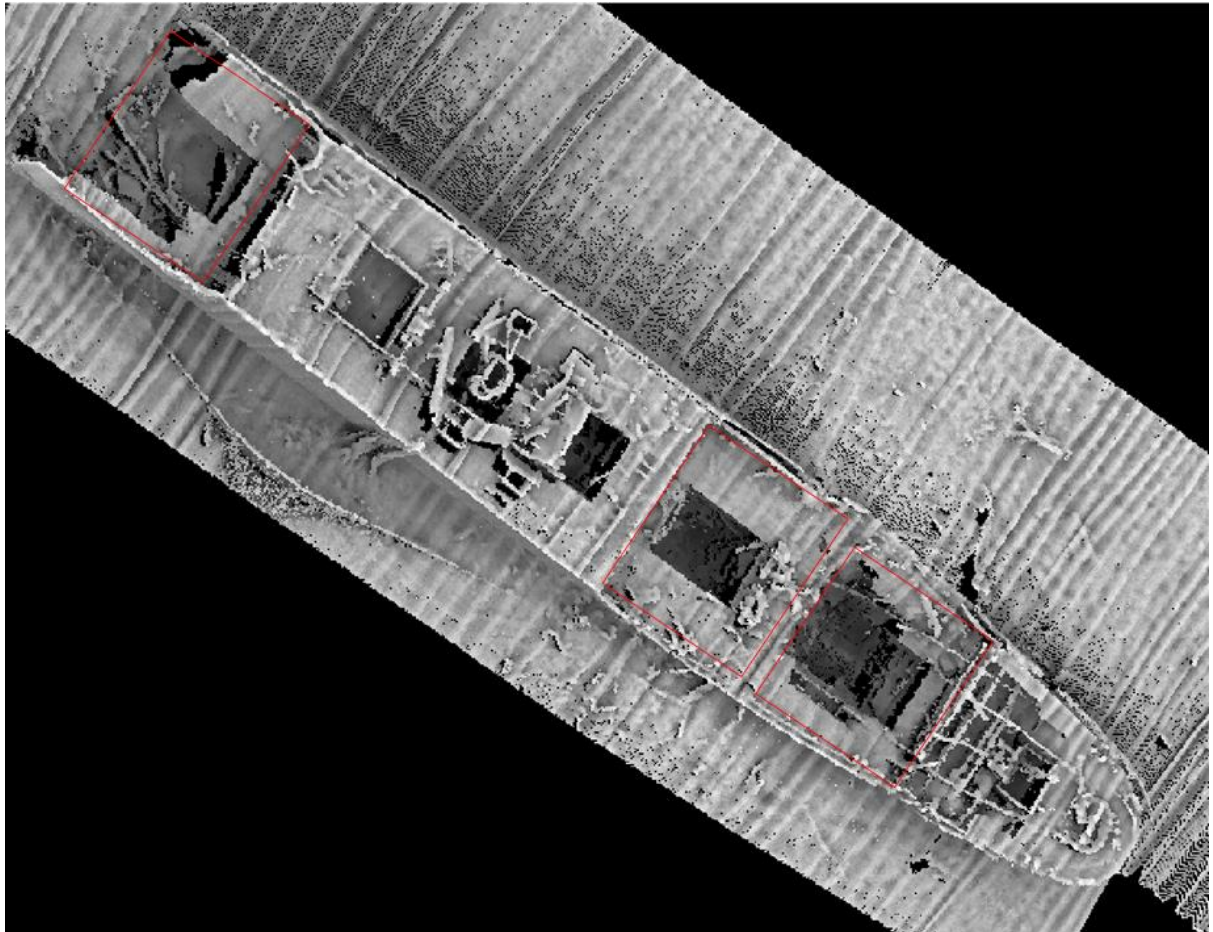
- Remove main decks and tween decks from marked areas (see image below)
- Removal of low value cargo (dumped 20m of the wreck)
- Removal of copper from the wreck

Image of the Cairnhill (target holds 2, 3 &4)

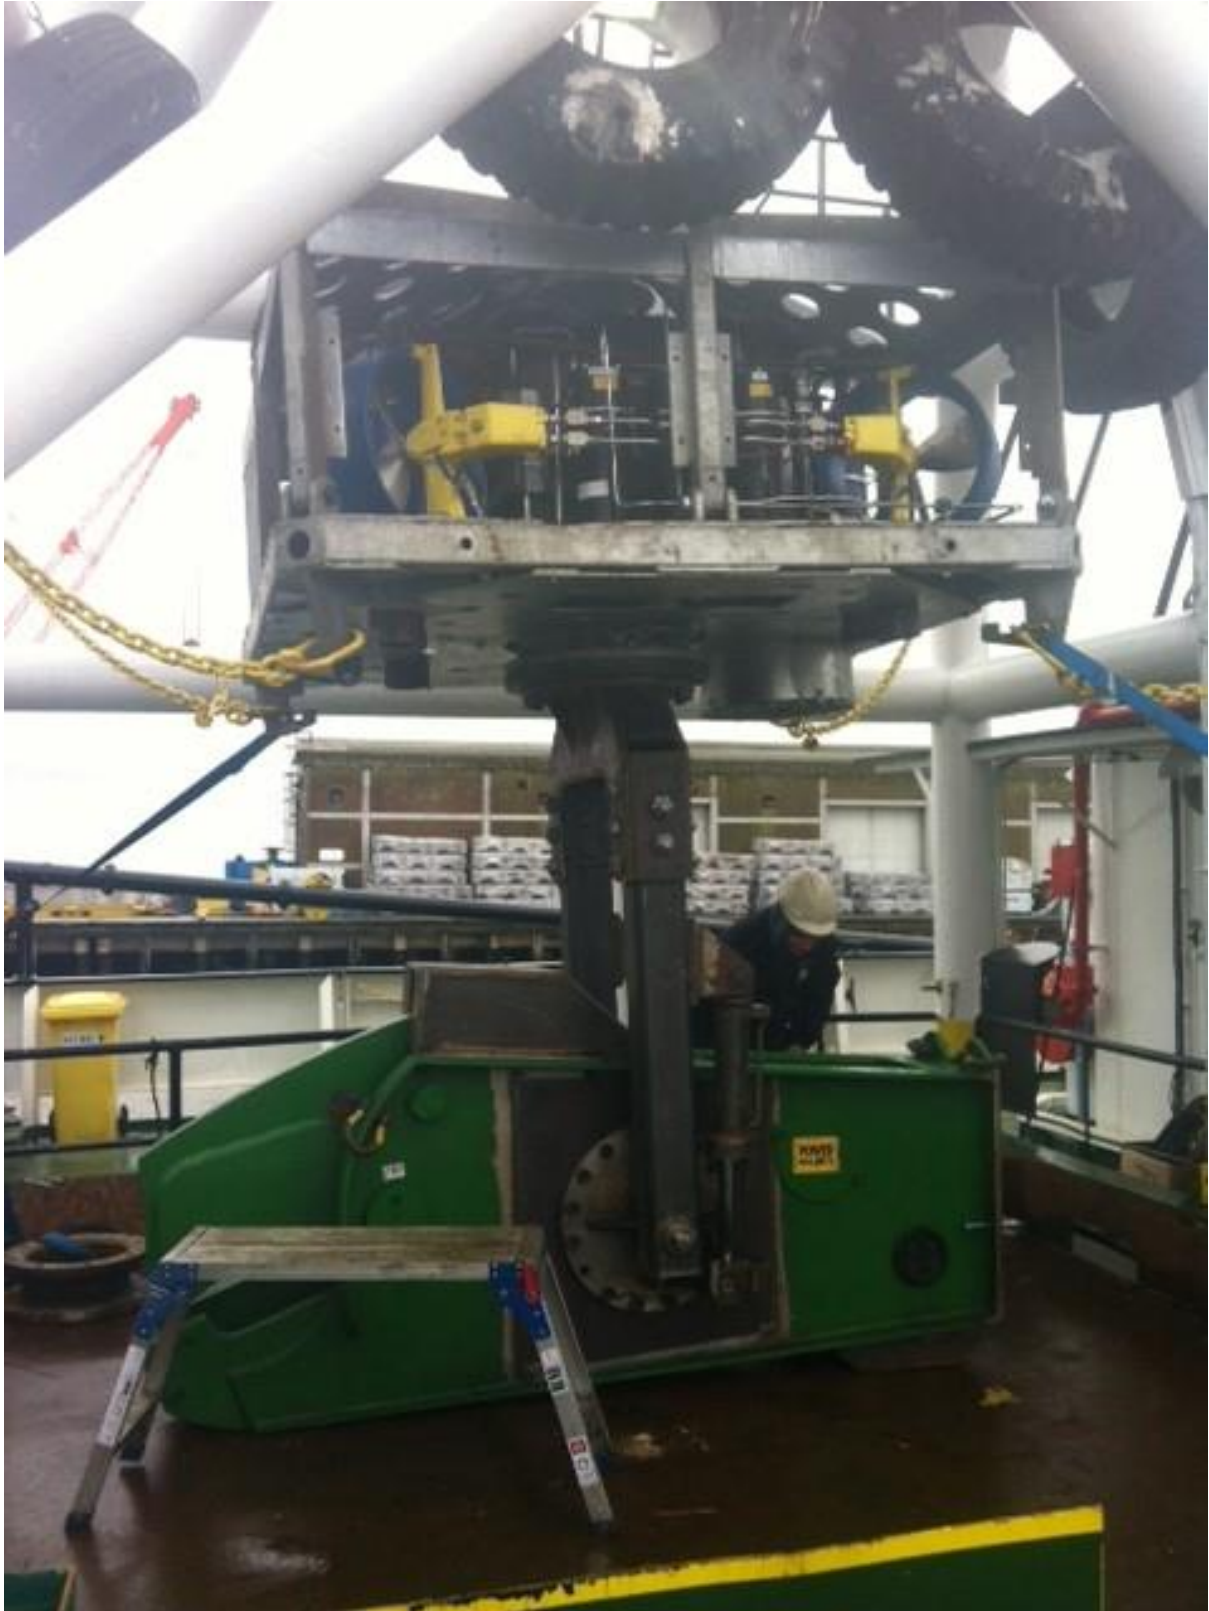
Shear grab fitted to the ROGE for the 1<sup>st</sup> time, the tilt frame allows for the shear to be adjusted between the horizontal and vertical position

To ensure this operation was carried out as efficiently as possible we modified a shear grab of a 25t excavator allowing us to cut through the main deck beams.

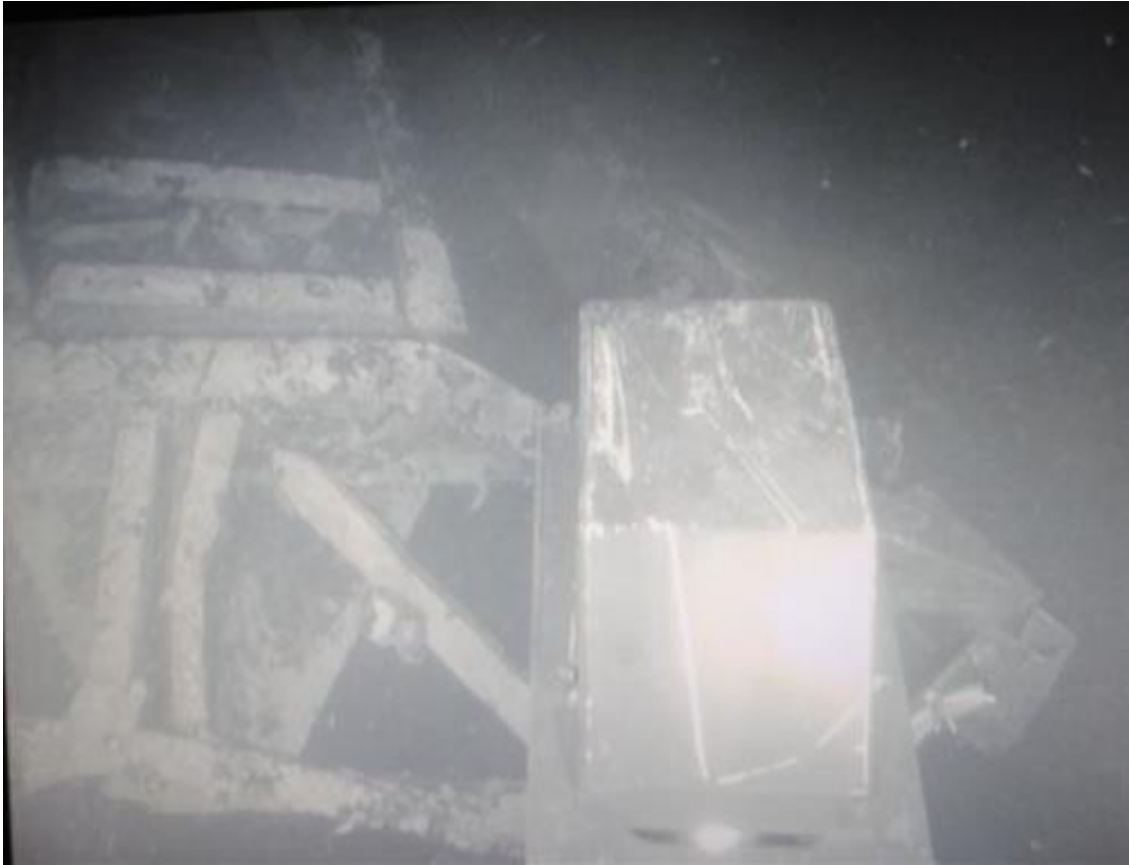
Shear in action cutting through deck beams

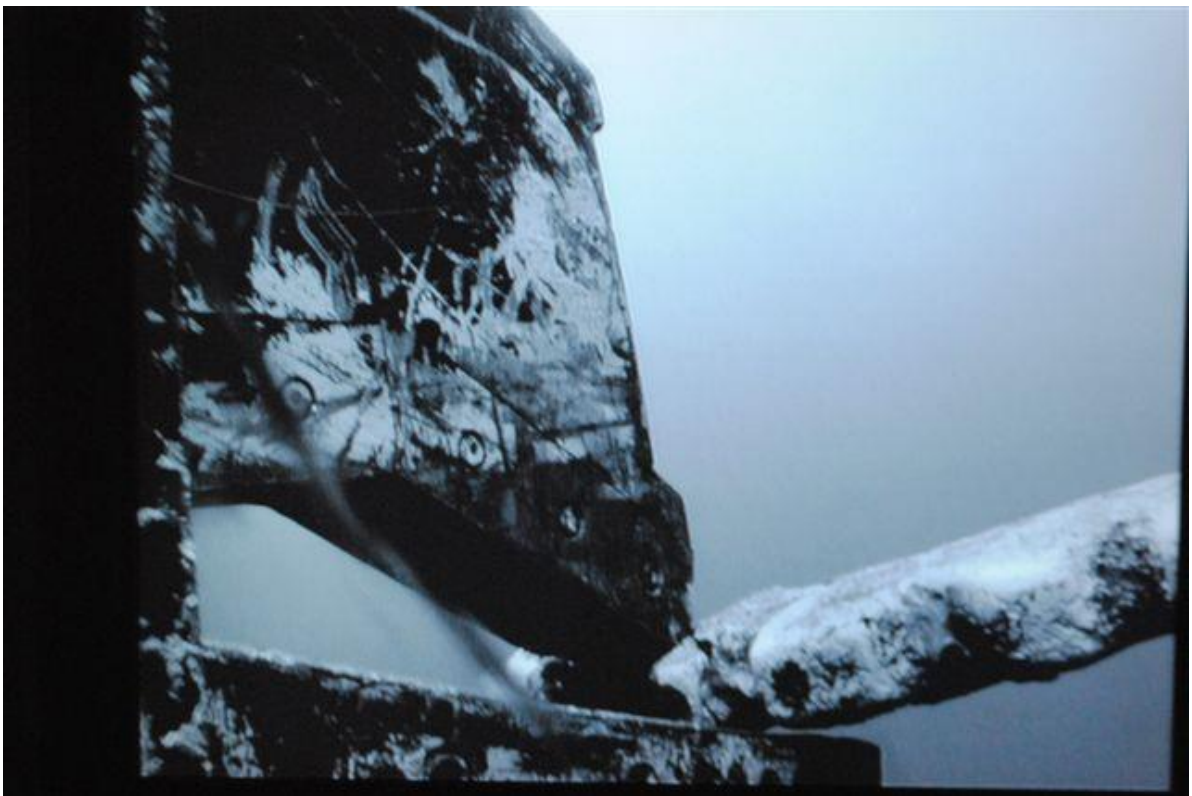
Shear taking a sample

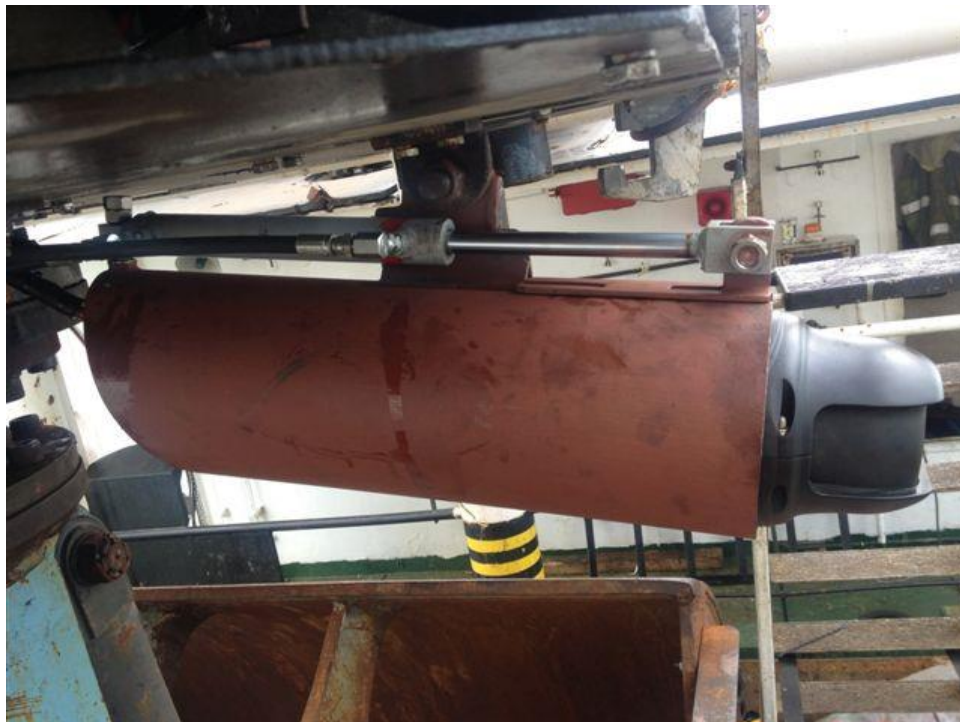
In addition to this we fitted an acoustic camera to the ROGE, due to the rough nature of work it was mounted on a retractable bracket to prevent damage

Out for operation

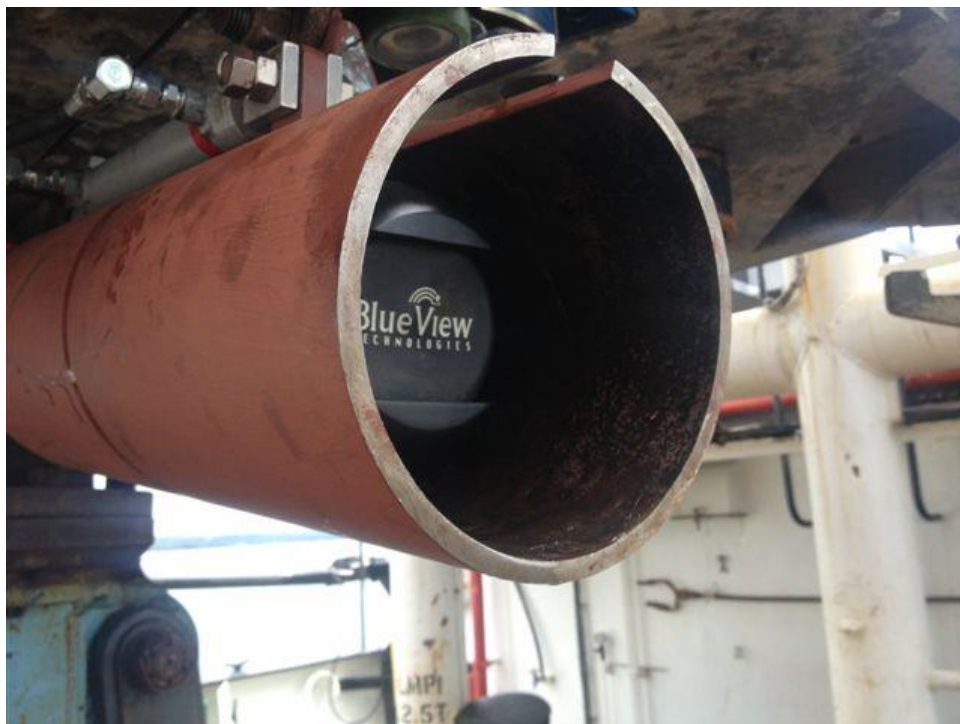
In for protection

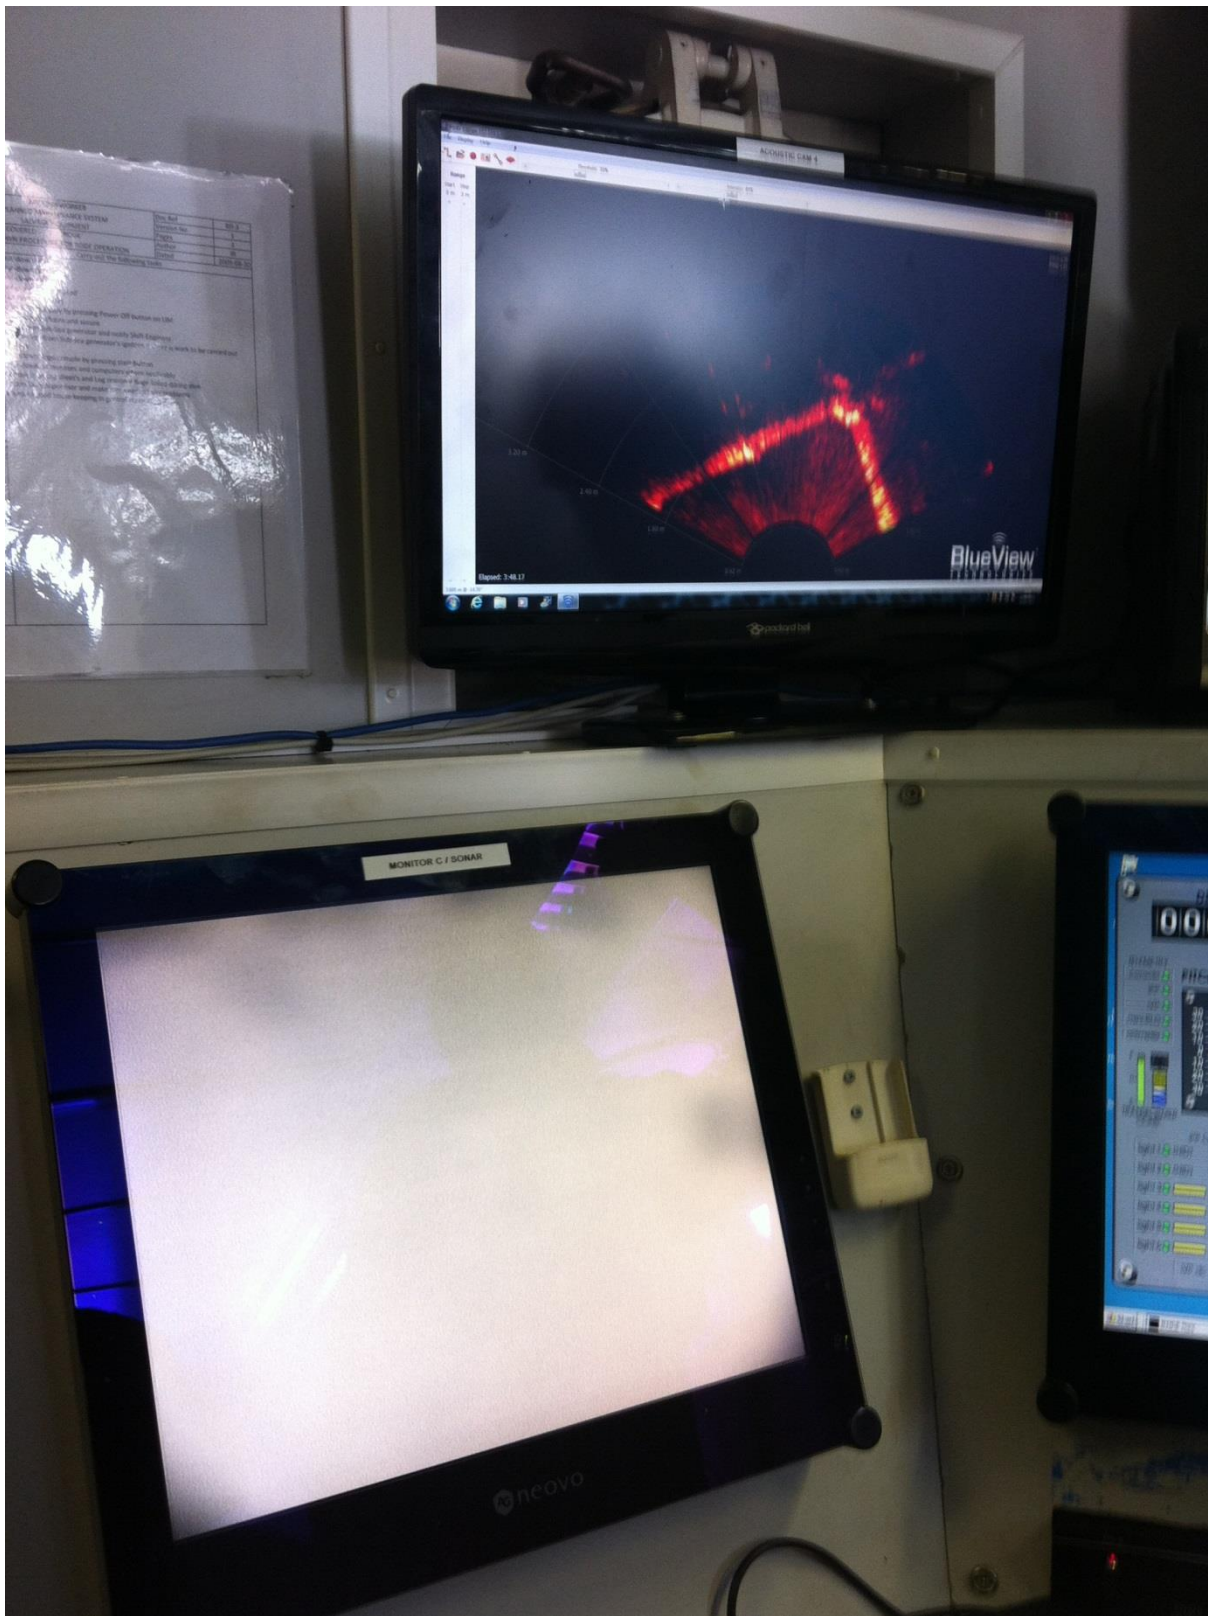
Comparison between the standard camera and the acoustic camera with the ROGE in the moonpool  
The shear operations were successfully completed in 3 weeks.

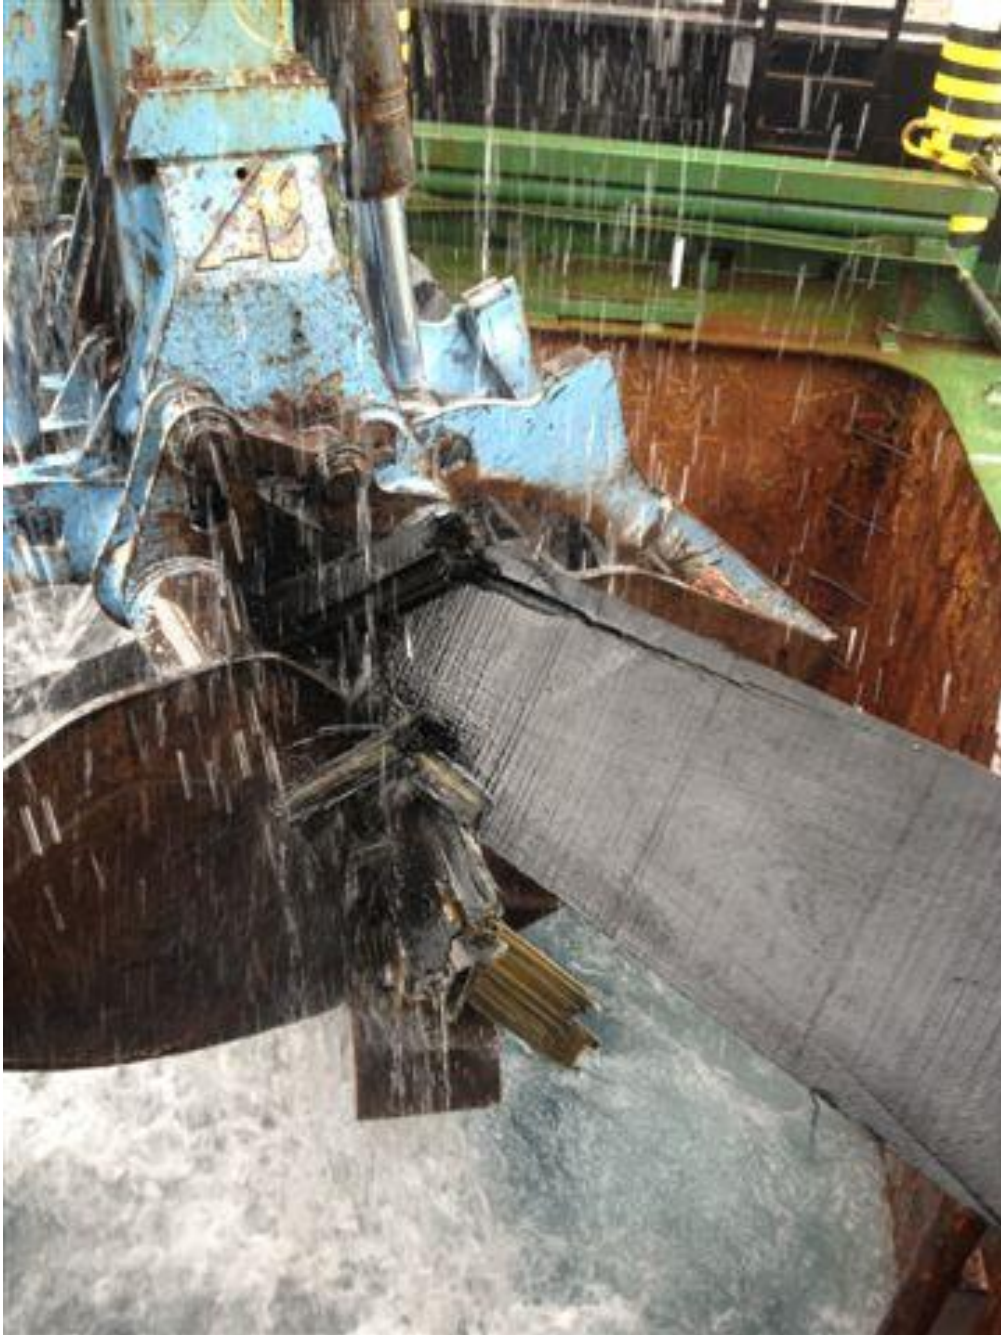
For removal of the bulk (zero value) cargo we modified a 2.5m<sup>3</sup> clamshell grab of a 40t excavator, with the addition of some teeth this was a very effective tool

Clamshell grab proved very effective for removal of bulk loose cargo

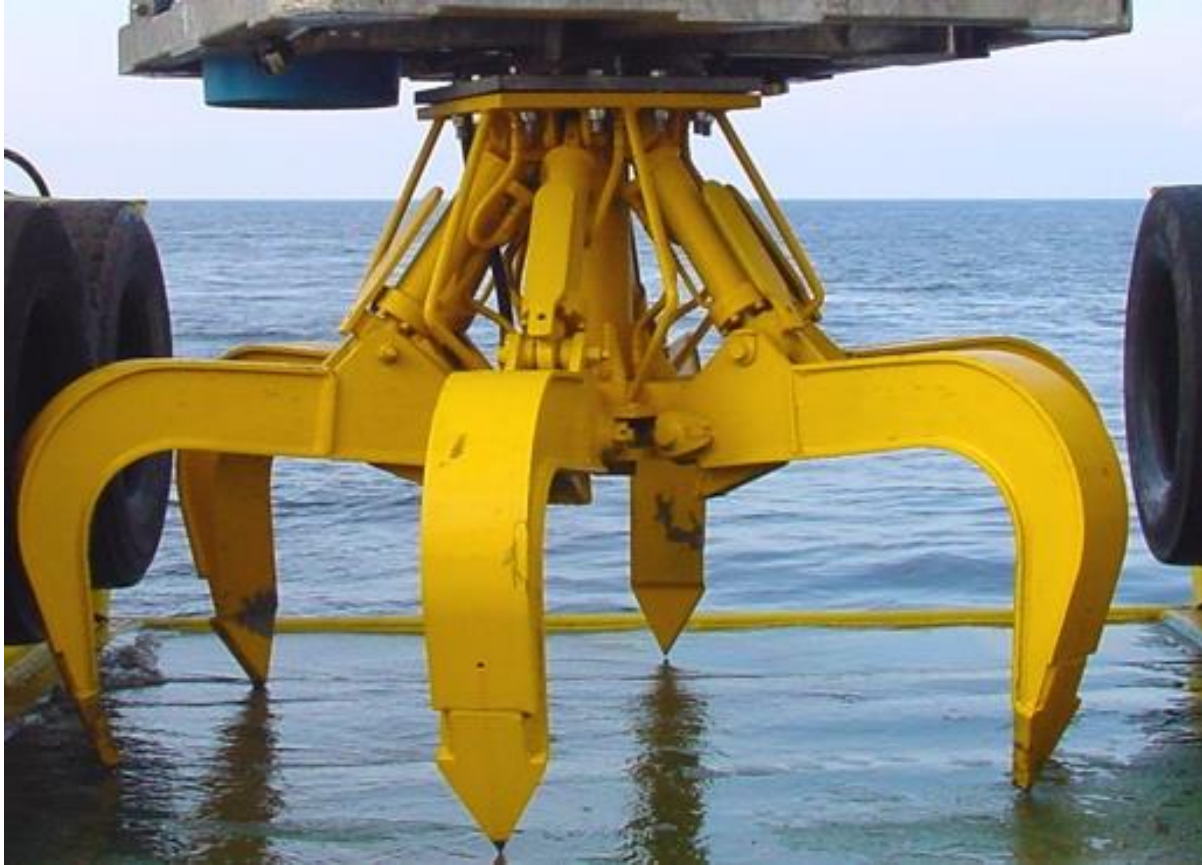
For removal of the cargo itself we use a tine grab which can effectively dig through tightly packed cargo, this grab is also useful for structure removal.
